# Home Inspection Report

**841 Glen Abbey Way Melbourne, FL 32940**

5-9-2007

05090701

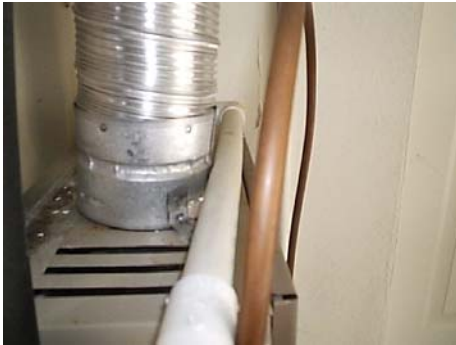
- **Repair:** The condensate line leading from the furnace is too close to the vent. It is scorching on the back side. Reroute with proper clearance from the vent.

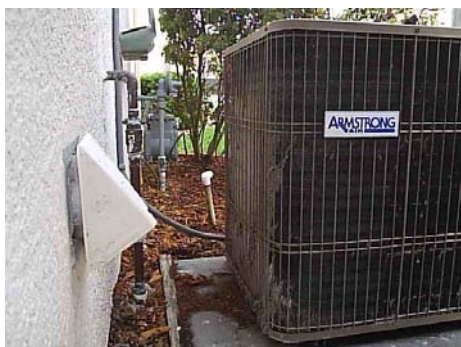
- **Repair:** The outdoor unit of the air conditioning system requires cleaning on the back side. The dryer vent needs to be adjusted so that it directs the lint away from the unit.

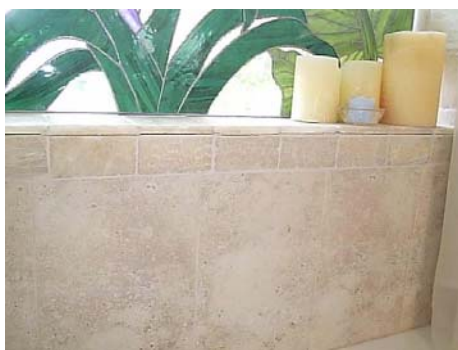
- **Repair:** Cracked, deteriorated and/or missing bathtub grout and caulk around the whirlpool should be replaced.

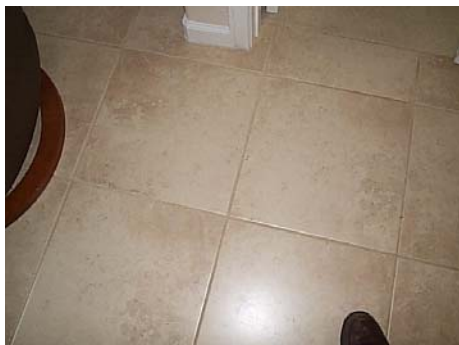
- **Monitor:** The tile floor grout in the living room is cracked.
