# Inspection Report

**Property Address:**  
1234 South St  
Titusville Fl 32780

**Bell Inspection Service**

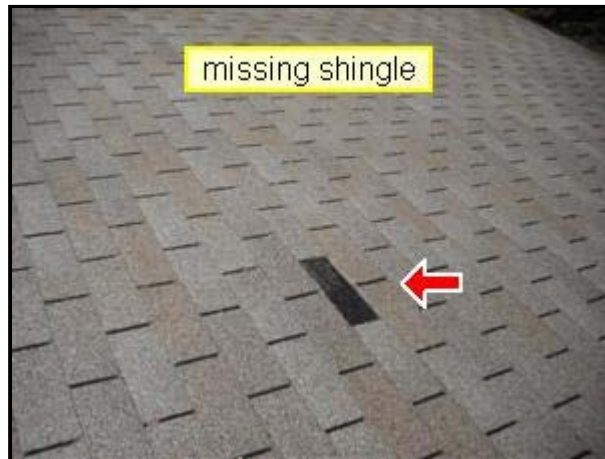
1.0 Picture 1

**1.0** The roof covering is nearing the end of its designed life. You should budget to replace the roof coverings in the near future. The roof coverings could last a couple more years. Monitor for leaks and damage. Consult with your home insurer to see what their position is concerning the age of the roof.

The roof covering is nearing the end of its designed life. You should budget to replace the roof coverings in the near future. The roof coverings could last a couple more years. Monitor for leaks and damage. Consult with your home insurer to see what their position is concerning the age of the roof.

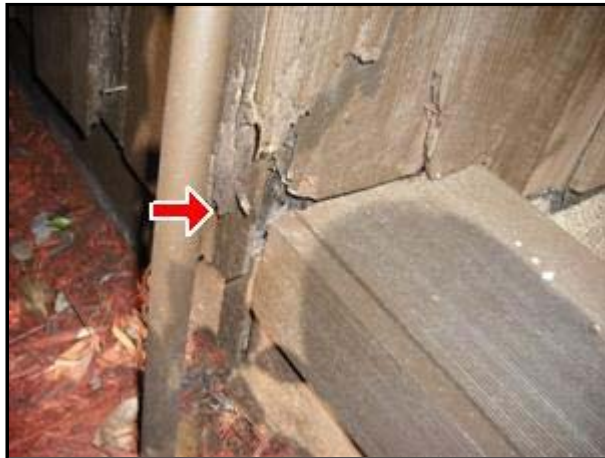
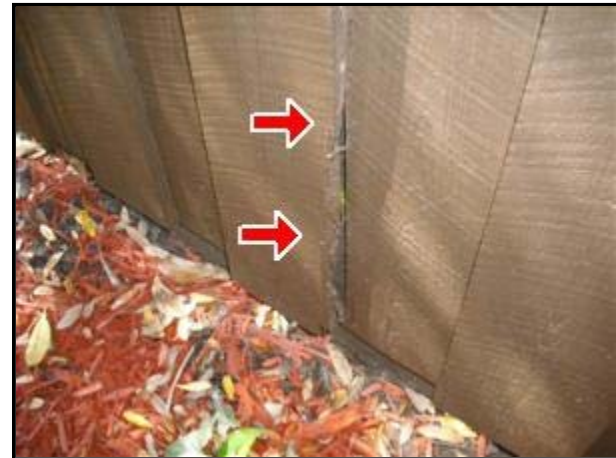
2.0 Picture 1

**2.0** The wood siding needs repair in numerous places on the exterior. The repairs include replacing wood decay and securing boards that are loose or cracked.

The wood siding needs repair in numerous places on the exterior. The repairs include replacing wood decay and securing boards that are loose or cracked.

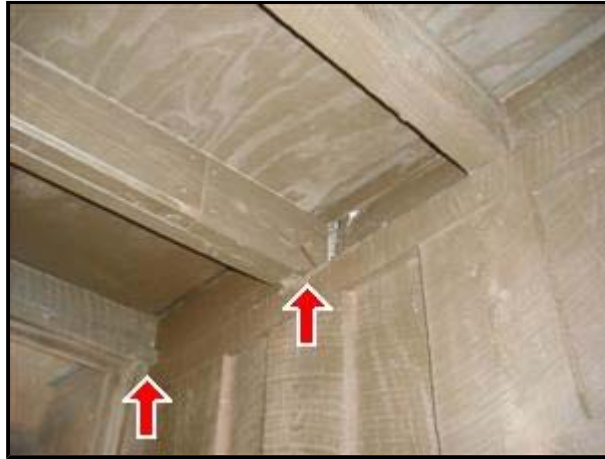
2.3 Picture 1

**2.3** Repairs have been made to the beams that support the second story deck. The materials used were not long enough so they do not bear on the frame of the home. Consult with a licensed contractor for repair.

Repairs have been made to the beams that support the second story deck. The materials used were not

long enough so they do not bear on the frame of the home. Consult with a licensed contractor for repair.

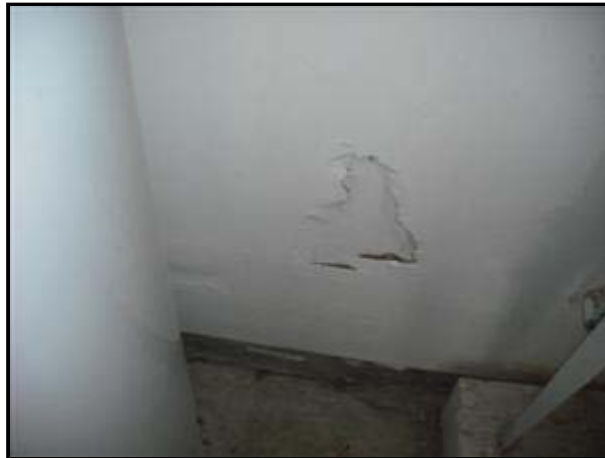
3.1 Picture 1

**3.1** There is drywall damage on the wall by the water heater. Repair as needed.

There is drywall damage on the wall by the water heater. Repair as needed.

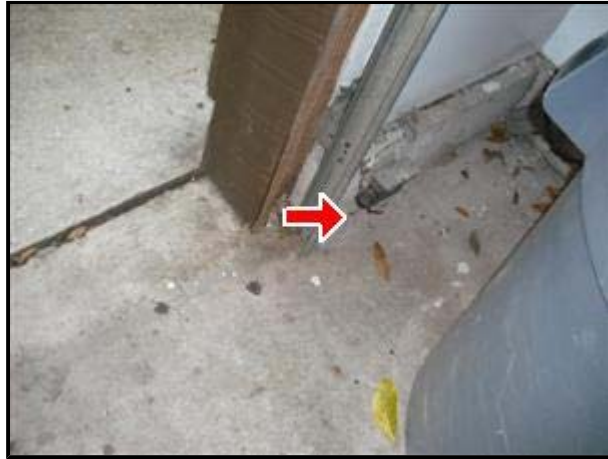
3.5 Picture 1

**3.5** The electronic eyes for the garage door should be within 2-4 inches of the garage floor. Move the electronic safety eyes to the proper level.

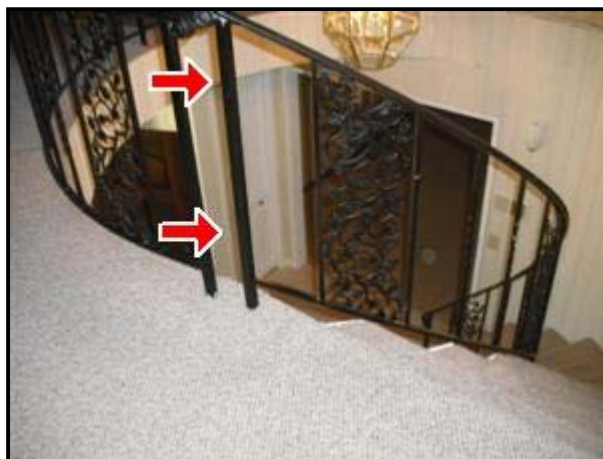
4.3 Picture 1

**4.3** The hand/guard rail for the second story stairs are spaced to far apart for safety and is weak and is not secure. A fall or injury could occur if not corrected. A qualified licensed contractor should repair or replace as needed.

The hand/guard rail for the second story stairs are spaced too far apart for safety and is weak and is not secure. A fall or injury could occur if not corrected. A qualified licensed contractor should repair or replace as needed.

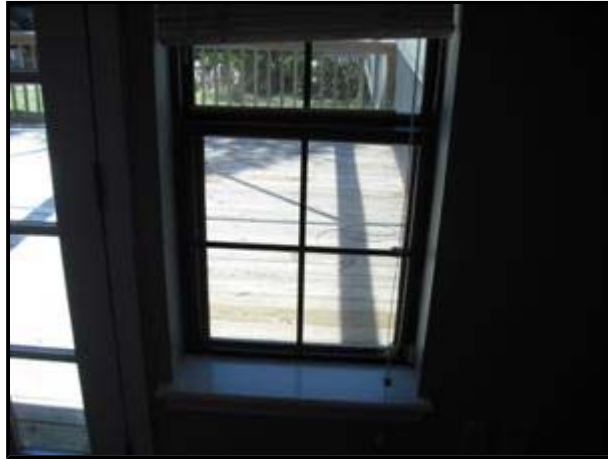
4.6 Picture 1

**4.6** The two windows on the west wall of the master bedroom need new springs. They will not stay open on their own.

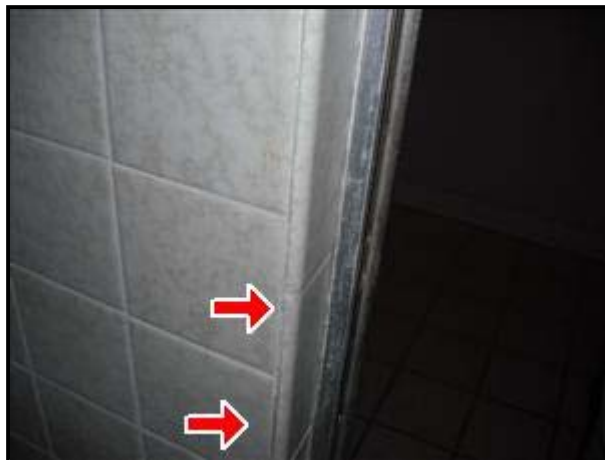
6.1 Picture 1

- 🏠 **6.1** Repair the caulk and grout where needed in tub and shower areas. This is a maintenance issue.

Repair the caulk and grout where needed in tub and shower areas. This is a maintenance issue.

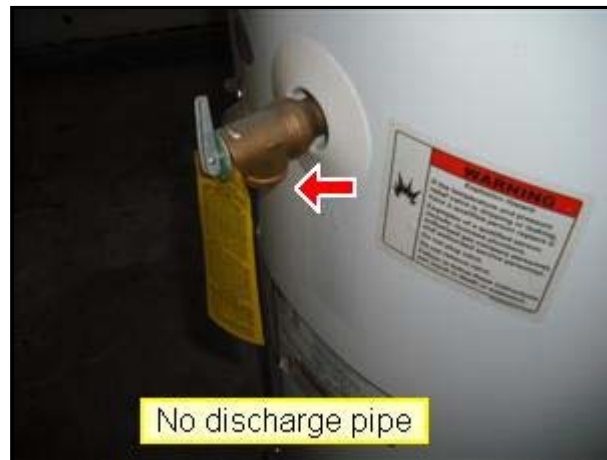
6.2 Picture 1

- 🏠 **6.2** The T&P (Test and Pressure) valve on water heater needs a 3/4 threaded pipe to extend within 6 inches of floor for safety. (PVC is not approved for hot water use). I recommend repair by a qualified person.

The T&P (Test and Pressure) valve on water heater needs a 3/4 threaded pipe to extend within 6 inches of floor for safety. (PVC is not approved for hot water use). I recommend repair by a qualified person.

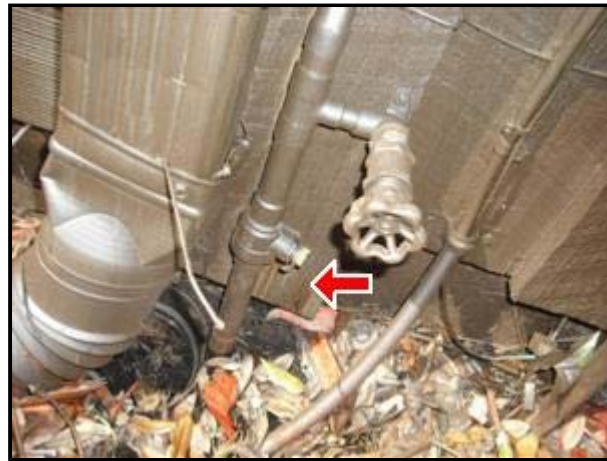
6.3 Picture 1

**6.3** The shutoff valve needs a new handle.

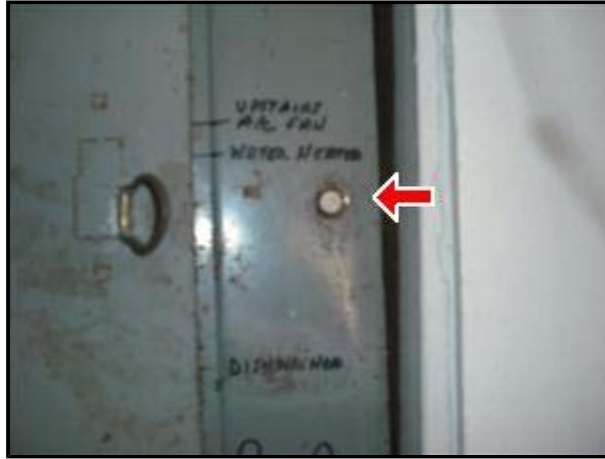
7.1 Picture 1

**7.1** (1) Some labels are present, but are illegible or confusing. I recommend correcting for safety reasons.

(2) Bolts are used to secure the dead front to the service panel. You risk penetrating one of the conductors when securing the panel cover to the panel. This is a safety hazard that needs to be repaired. Replace current bolts with blunt ended screws that are designed for electrical panels. The dead front was not removed for this reason.

(1) Some labels are present, but are illegible or confusing. I recommend correcting for safety reasons.

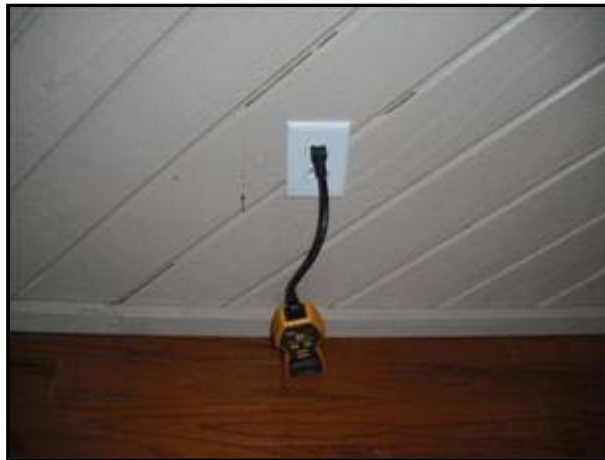
7.3 Picture 1

**7.3** (1) The outlet on the east wall of the family room has reversed polarity (wired backwards). This can cause damage for any item that uses this outlet. Consult with a licensed electrician for repair.

(1) The outlet on the east wall of the family room has reversed polarity (wired backwards). This can cause damage for any item that uses this outlet. Consult with a licensed electrician for repair.

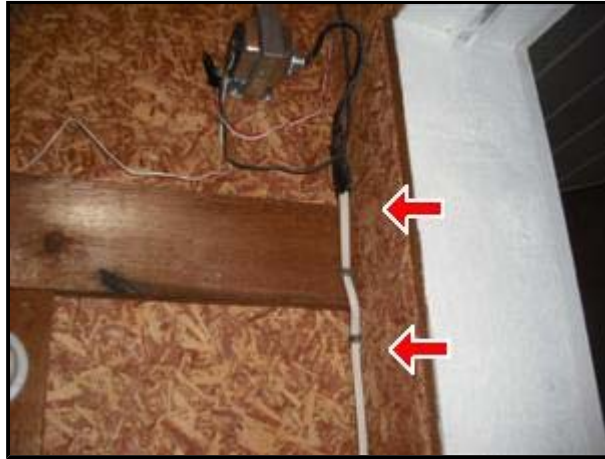
7.3 Picture 2

(2) All exposed conductors in the home should be in conduit. This is a safety hazard. Consult with a licensed electrician for repair.

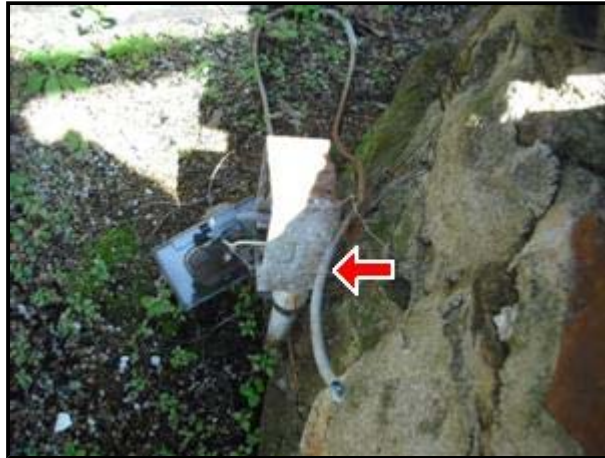
7.4 Picture 1

**7.4** The outlet by the waterfall is exposed and out of the box. This is a safety hazard that should be repaired.

The outlet by the waterfall is exposed and out of the box. This is a safety hazard that should be repaired.

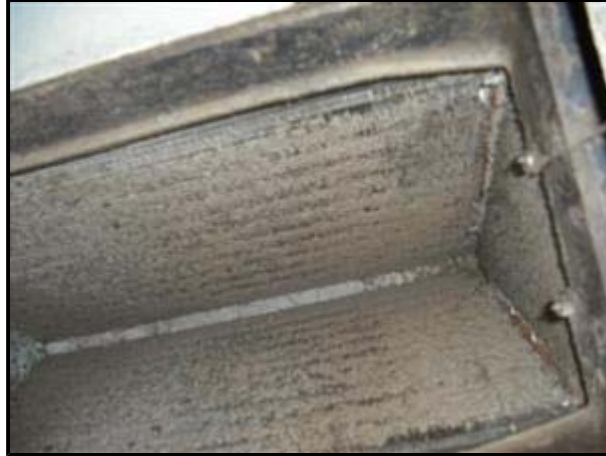
8.0 Picture 1

**8.0** The coils for the air handler are very dirty and have a mold like substance growing on them. This

condition will restrict the air flow and cause the unit to prematurely fail. Consult with a licensed AC Contractor for repair.

The coils for the air handler are very dirty and have a mold like substance growing on them. This condition will restrict the air flow and cause the unit to prematurely fail. Consult with a licensed AC Contractor for repair.

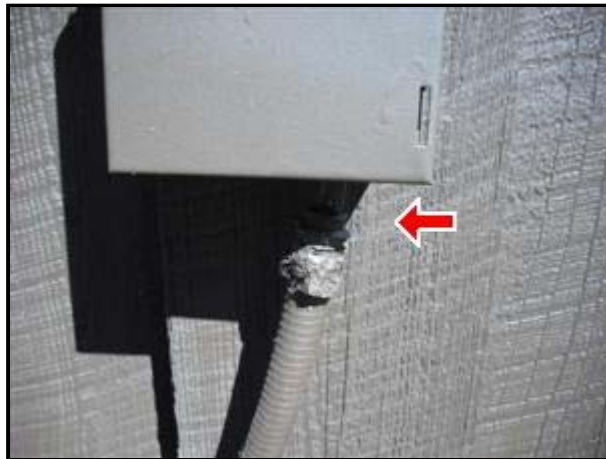
8.7 Picture 1

(4) The conduit to the condenser disconnect needs to be attached to the box.
