# Home Inspection Report

**841 Glen Abbey Way Melbourne, FL 32940**

5-9-2007

05090701

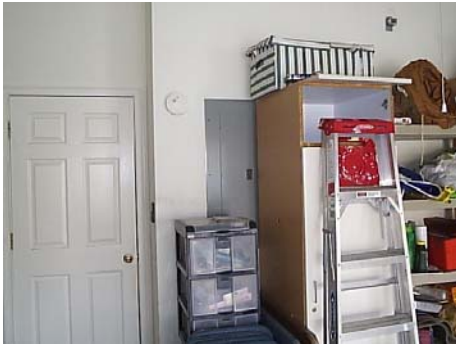
## ELECTRICAL OBSERVATIONS

The size of the electrical service is sufficient for typical single family needs. Generally speaking, the electrical system is in good order.

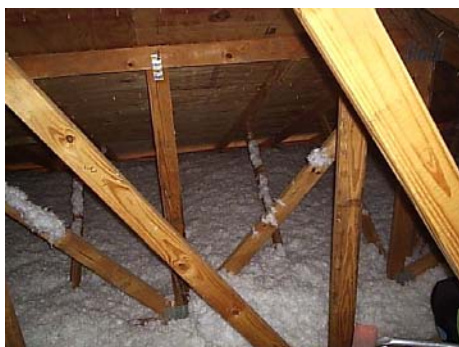
## INSULATION / VENTILATION OBSERVATIONS

Insulation levels are typical for a home of this age and construction.
